Lake Wallkill Dam (NJ-00032)
Hudson River Basin, Wallkill River,
Tributary, Sussex County, New Jersey
Phase 1 Inspection Report.

| REPORT DOCUMENTATION PAGE | | READ INSTRUCTIONS BEFORE COMPLETING FORM |
|--|---|--|
| 4. TITLE (and Subtitle) Phase I Inspection Report National Dam Safety Program Lake Wallkill Dam Sussex County, N.J. | | 5. TYPE OF REPORT & PERIOD COVERED FINAL |

LAKE WALLKILL DAM (NJ00032)

PHASE I REPORT
NATIONAL DAM INSPECTION PROGRAM

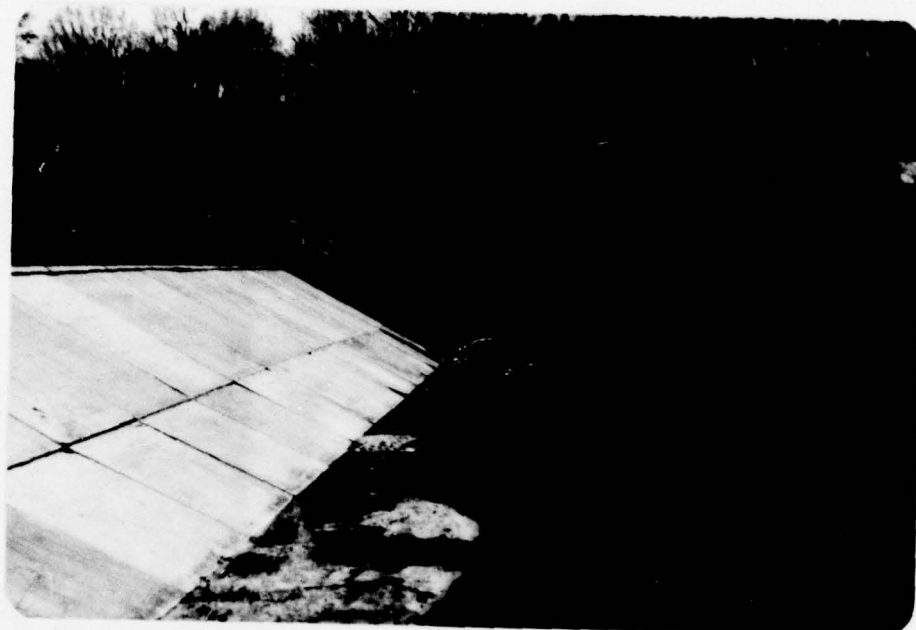
| VISUAL EXAMINATION OF | OBSERVATIONS | REMARKS OR RECOMMENDATIONS |
|--|---|--|
| CRACKING AND SPALLING OF CONCRETE SURFACES IN OUTLET CONDUIT | Light deterioration of outlet pipe - Chipping and some spalling at the lip of the pipe. | |

View of Primary Spillway Outlet

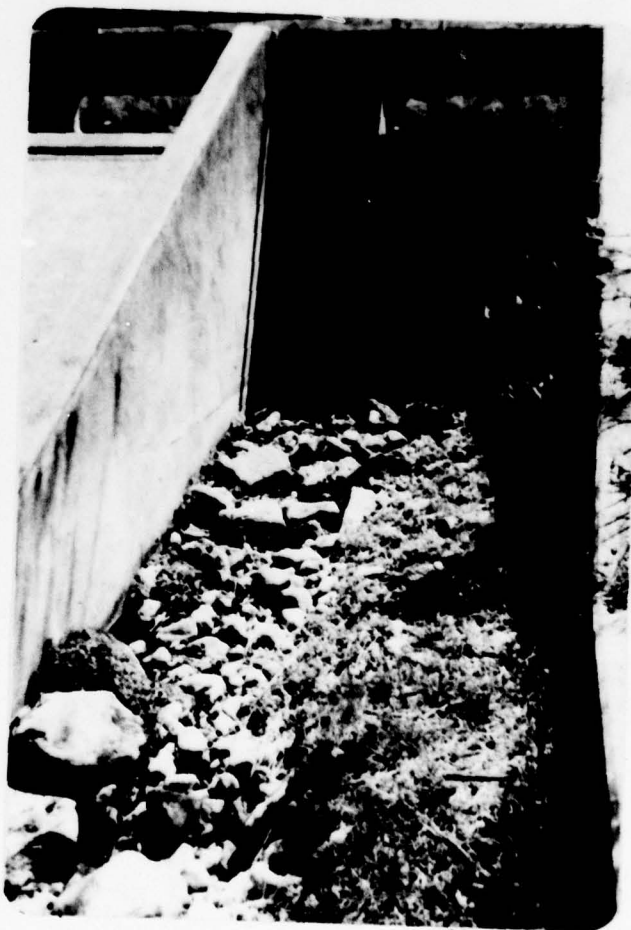
| VISUAL EXAMINATION OF | OBSERVATIONS | REMARKS OR RECOMMENDATIONS |
|---|---|---|
| STRUCTURAL CRACKING | Retaining wall and wingwalls exhibit light surface deterioration consonant with their age. Piers appear in good shape. Right wingwall of gated sluiceway slightly undercut at toe. | |

View of Sluiceway Outlet Channel
